**Flood Control Project Maintenance
Levee Inspections**

Fall 2011 Levee Maintenance Deficiency Summary Report

San Joaquin River Basin

Reclamation District No. 2062 Stewart

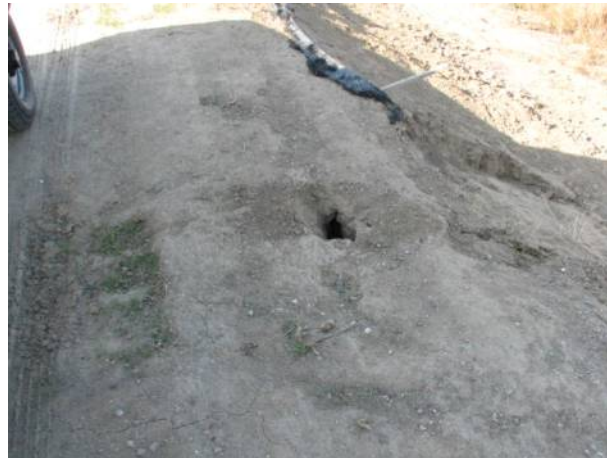
Levee Mile Report Line	1
Start Levee Mile	0.49
End Levee Mile	0.49
Location	Crown
Category	Earthen Levee
Item	Animal Control
10/21/2011 Photo of burrow on crown, photo was taken day after inspection.	
jeto_f_20111031_495.jpg

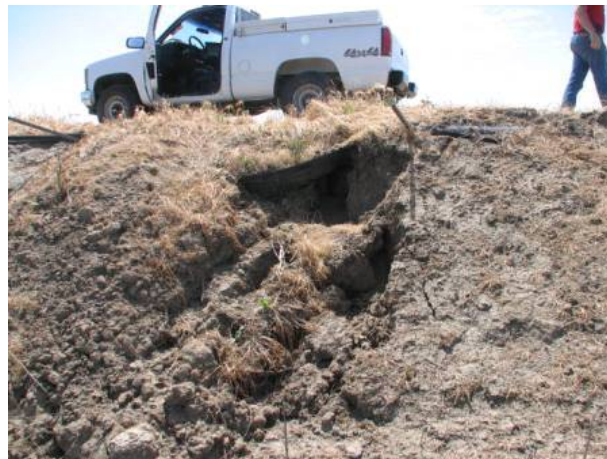
Levee Mile Report Line	2
Start Levee Mile	0.50
End Levee Mile	0.50
Location	Water Side
Category	Earthen Levee
Item	Erosion / Bank Caving
05/11/2011 Erosion at crown, vegetation shown at top of erosion is being supported by silt fence.	
jeto_f_20110923_166.jpg

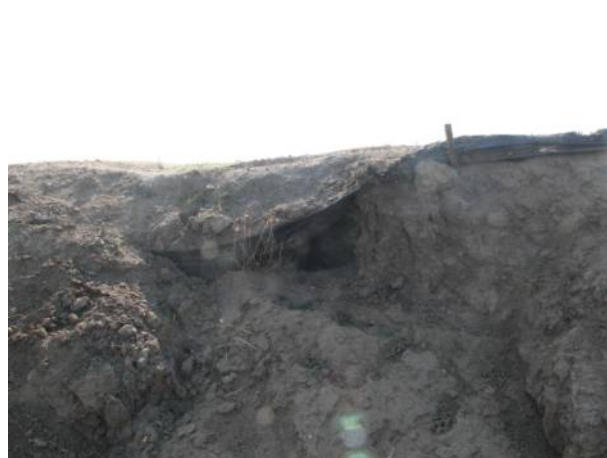
Levee Mile Report Line	2
Start Levee Mile	0.50
End Levee Mile	0.50
Location	Water Side
Category	Earthen Levee
Item	Erosion / Bank Caving
10/21/2011 Erosion at crown, issue first noted in Spring 2011 inspection.	
jeto_f_20111031_496.jpg

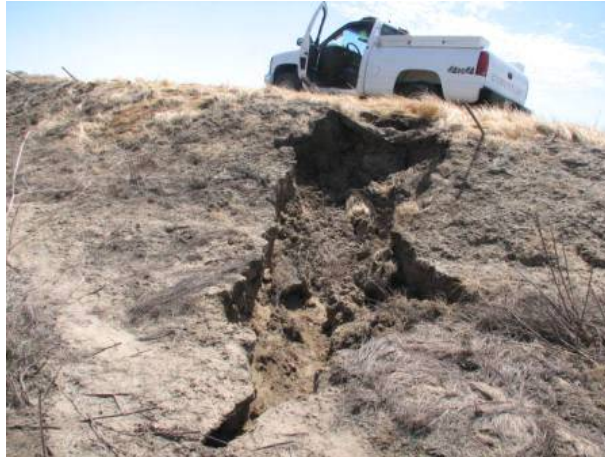
Levee Mile Report Line	3
Start Levee Mile	0.57
End Levee Mile	0.57
Location	Water Side
Category	Earthen Levee
Item	Erosion / Bank Caving
05/11/2011 Erosion begins at crown, stakes shown in photo are supporting a silt fence. Silt fence is supporting soil and vegetation at crown.	
jeto_f_20110923_167.jpg

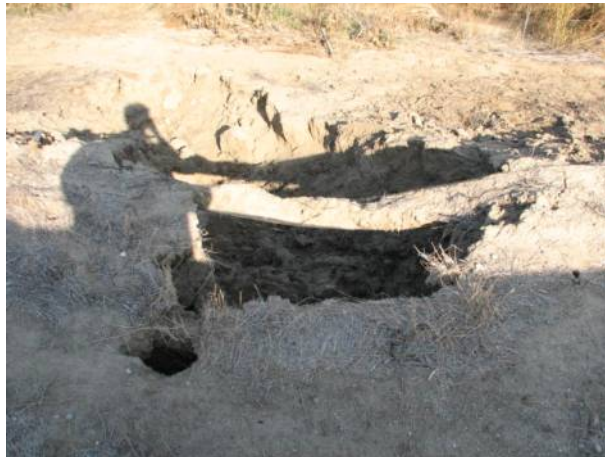
Levee Mile Report Line	3
Start Levee Mile	0.57
End Levee Mile	0.57
Location	Water Side
Category	Earthen Levee
Item	Erosion / Bank Caving
10/21/2011 Photo is taken from levee crown, issue has still not been addressed. Issue was noted in the Spring 2011 inspection.	
jeto_f_20111031_497.jpg

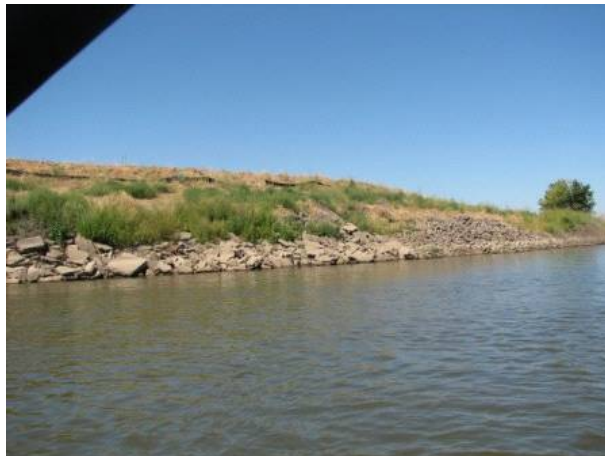
Levee Mile Report Line	6
Start Levee Mile	0.91
End Levee Mile	0.91
Location	Water Side
Category	Supplemental
Item	DWR Erosion Survey
Front view of the erosion	
SJR2011_RD2062U01RM54.14_1.jpg

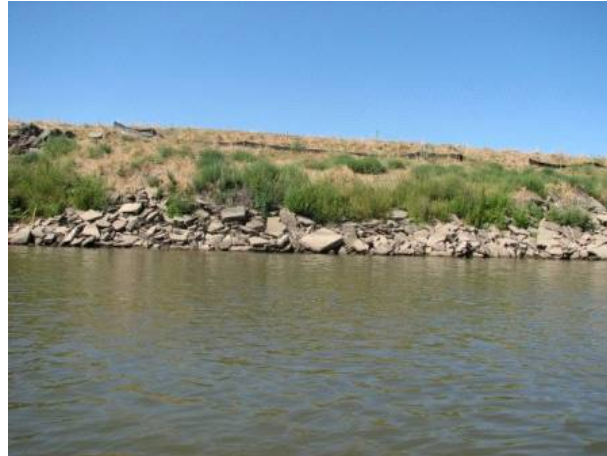
SJR2011_RD2062U01RM54.14_2.jpg

Front view of the rip rap

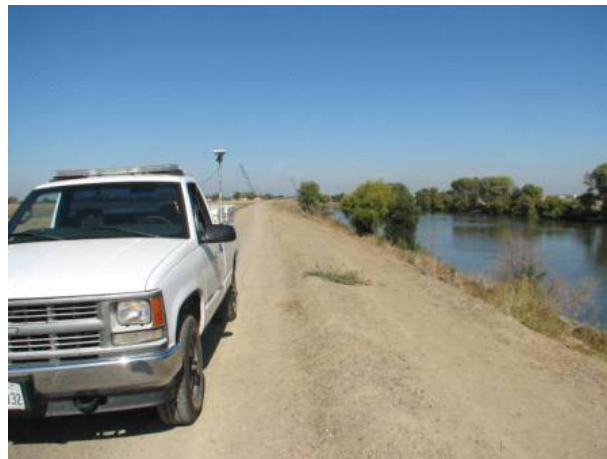
jeto_f_20111024_491.jpg

7	1.18	1.40	Earthen Levee	Crown Surface / Depressions / Rutting	CR	U	Regrade the crown roadway for proper drainage. Inspector Comments: High shoulder and slope of road will cause deep ponding. Approximately 1' deep.	37.800147 ° -121.313703 °	37.797164 ° -121.313976 °	15 Y
8	1.55	1.55	Earthen Levee	Animal Control	WS	C	No rodents visible, but rodent burrows visible; need to backfill and compact or grout burrows.	37.795102 ° -121.315068 °	37.795102 ° -121.315068 °	9
9	1.67	1.67	Earthen Levee	Encroachments	WS	W	Pipe	37.793516 ° -121.315335 °	37.793516 ° -121.315335 °	10
10	1.83	1.83	Earthen Levee	Animal Control	WS	M	No rodents visible, but rodent burrows visible; need to backfill and compact or grout burrows.	37.791873 ° -121.313350 °	37.791873 ° -121.313350 °	11 Y

Levee Mile Report Line	7
Start Levee Mile	1.18
End Levee Mile	1.40
Location	Crown
Category	Earthen Levee
Item	Crown Surface / Depressions / Rutting

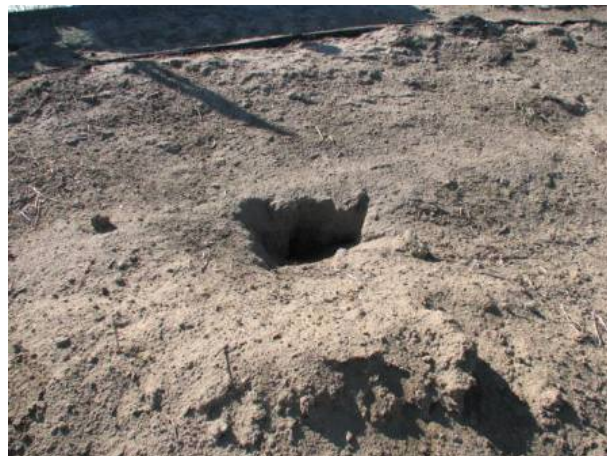
jeto_f_20111024_492.jpg

Levee Mile Report Line	10
Start Levee Mile	1.83
End Levee Mile	1.83
Location	Water Side
Category	Earthen Levee
Item	Animal Control

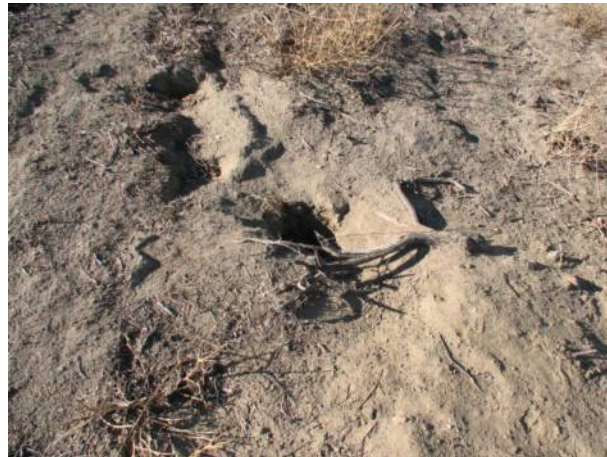
Levee Mile Report Line	10
Start Levee Mile	1.83
End Levee Mile	1.83
Location	Water Side
Category	Earthen Levee
Item	Animal Control
10/20/2011 Large burrow located on waterside slope of levee.	
jeto_f_20111024_494.jpg

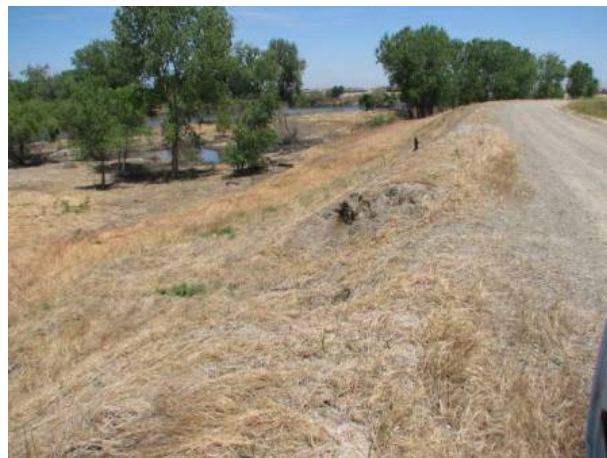
Levee Mile Report Line	13
Start Levee Mile	2.10
End Levee Mile	2.10
Location	Water Side
Category	Earthen Levee
Item	Slope Stability
05/11/2011 Damage seen in photo continues down the slope as if area was being used by equipment to access the bank.	
jeto_f_20110923_168.jpg

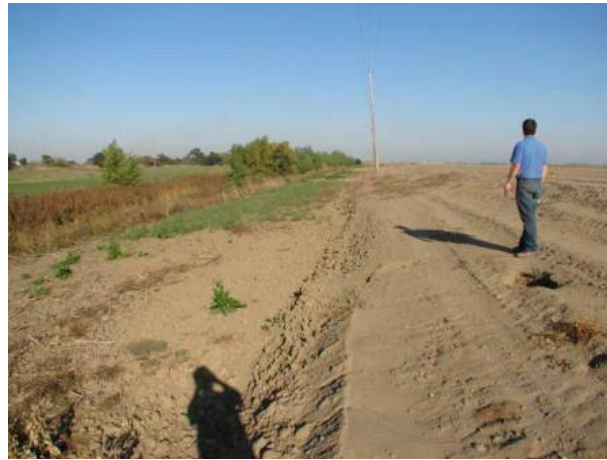
jeto_f_20111024_480.jpg

10/20/2011 Photo shows issue caused by discing (left side of photo) of the weeds on the waterside.

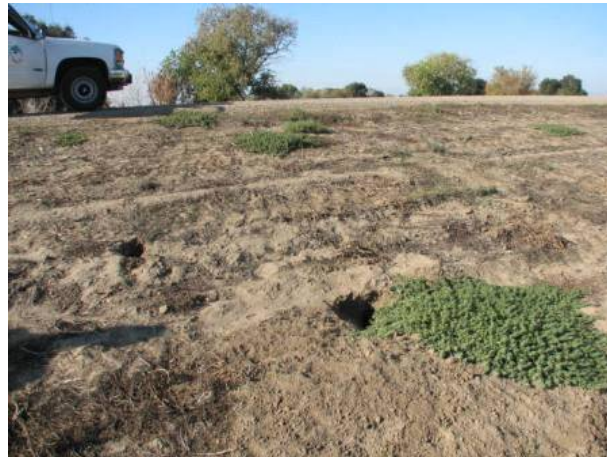
jeto_f_20111024_481.jpg

Levee Mile Report Line	7
Start Levee Mile	2.04
End Levee Mile	2.04
Location	Land Side
Category	Earthen Levee
Item	Animal Control

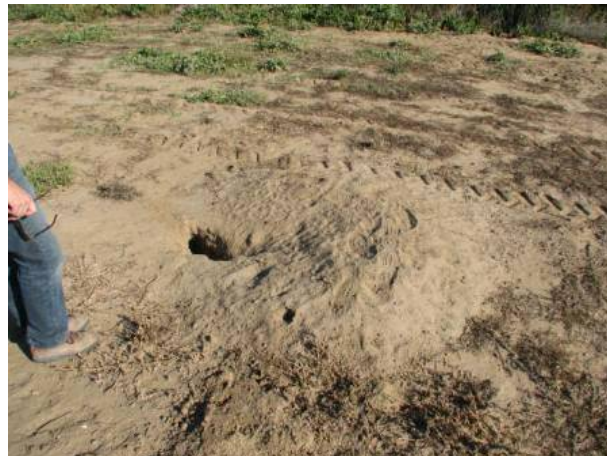
jeto_f_20111024_482.jpg

Levee Mile Report Line	8
Start Levee Mile	2.10
End Levee Mile	2.10
Location	Land Side
Category	Earthen Levee
Item	Animal Control

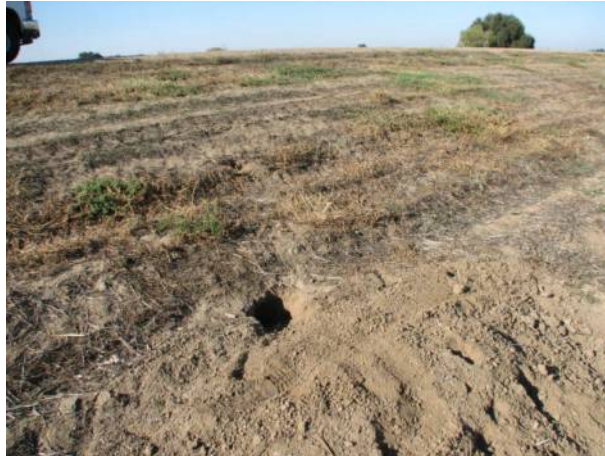
Levee Mile Report Line	9
Start Levee Mile	2.19
End Levee Mile	2.19
Location	Land Side
Category	Earthen Levee
Item	Animal Control
10/20/211 Single large burrow on landside, appears to be active.	
jeto_f_20111024_483.jpg

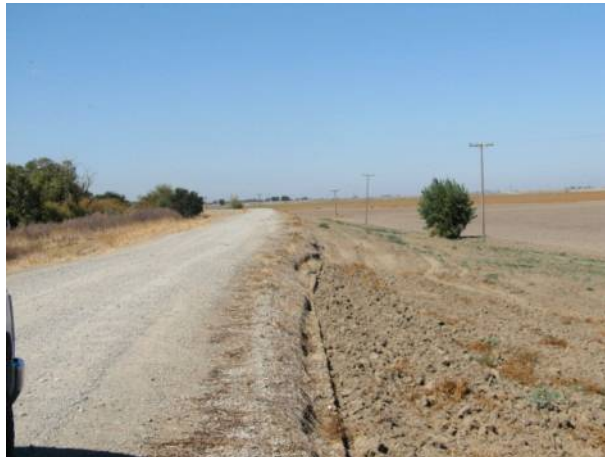
Levee Mile Report Line	11
Start Levee Mile	2.54
End Levee Mile	3.94
Location	Land Side
Category	Earthen Levee
Item	Encroachments
Discing on levee slopes has created a substantial vertical scarp.	
jeto_f_20110923_178.jpg

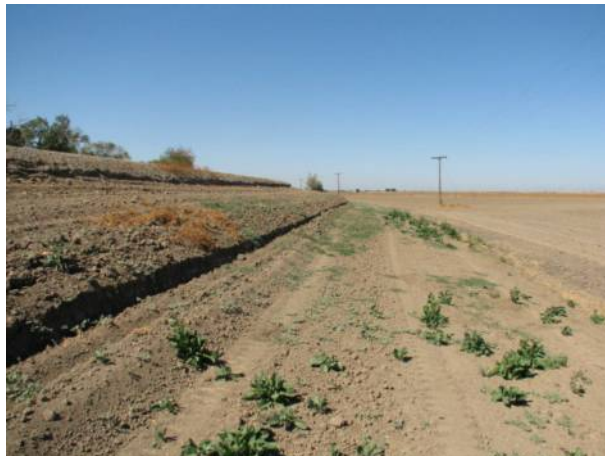
Levee Mile Report Line	11
Start Levee Mile	2.54
End Levee Mile	3.94
Location	Land Side
Category	Earthen Levee
Item	Encroachments
Discing on levee slopes has created two substantial vertical scarps.	
jeto_f_20110923_179.jpg

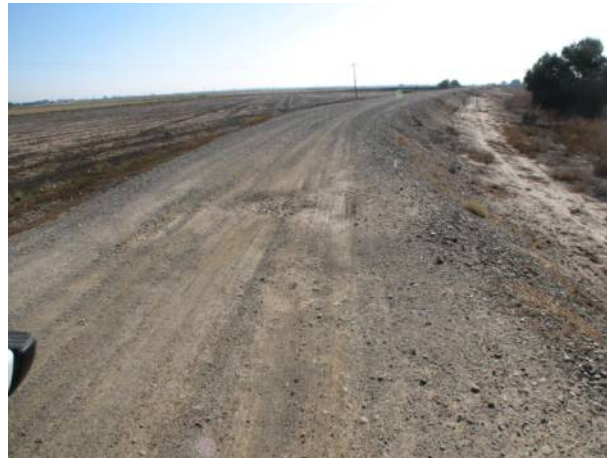
Levee Mile Report Line	12
Start Levee Mile	2.81
End Levee Mile	2.81
Location	Water Side
Category	Earthen Levee
Item	Crown Surface / Depressions / Rutting
10/20/2011 Minor pothole, shows evidence of holding water.	
jeto_f_20111024_484.jpg

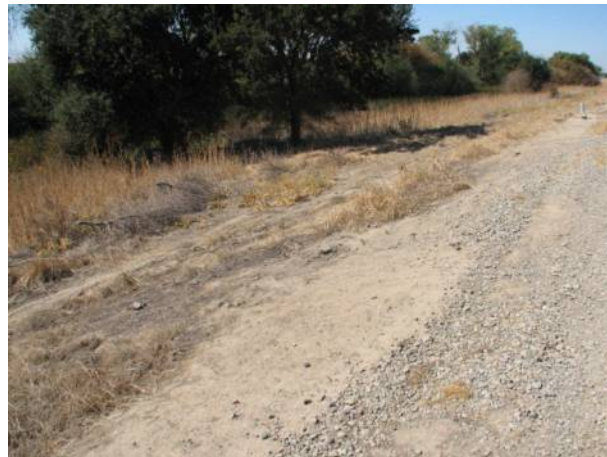
Levee Mile Report Line	13
Start Levee Mile	2.89
End Levee Mile	2.89
Location	Water Side
Category	Earthen Levee
Item	Trim / Thin Trees
Three small stumps on levee slope.	
jeto_f_20110923_177.jpg

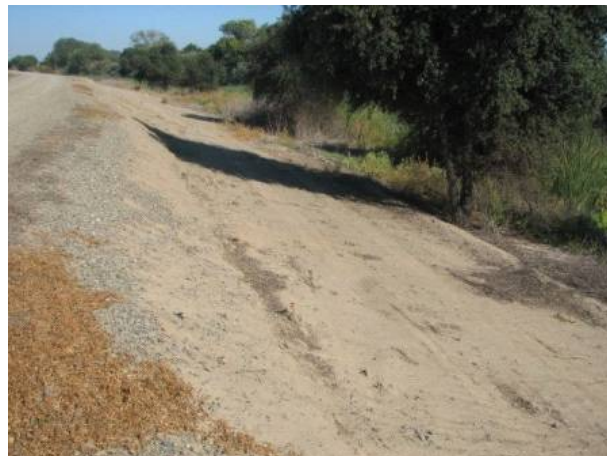
Levee Mile Report Line	18
Start Levee Mile	3.27
End Levee Mile	3.28
Location	Water Side
Category	Supplemental
Item	DWR Erosion Survey
Downstream view of scarp caused by a maintenance equipment.	
SJR2011_RD2062U02RM2.14_1.jpg

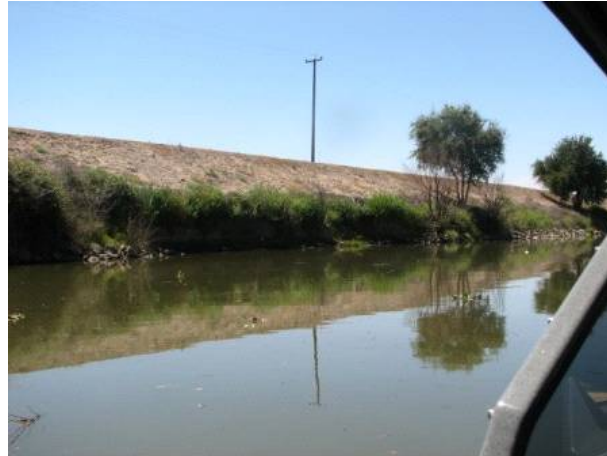
Levee Mile Report Line	6
Start Levee Mile	0.23
End Levee Mile	0.32
Location	Water Side
Category	Supplemental
Item	DWR Erosion Survey
Downstream view of the 5-ft vertical scarp .	
SJ2011_RD2062U03RM30.19_1.jpg

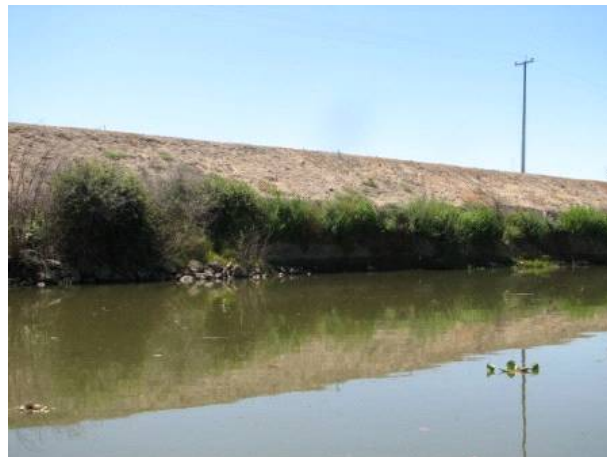
Levee Mile Report Line	6
Start Levee Mile	0.23
End Levee Mile	0.32
Location	Water Side
Category	Supplemental
Item	DWR Erosion Survey
Another view of the same 5-ft scarp.	
SJ2011_RD2062U03RM30.19_2.jpg

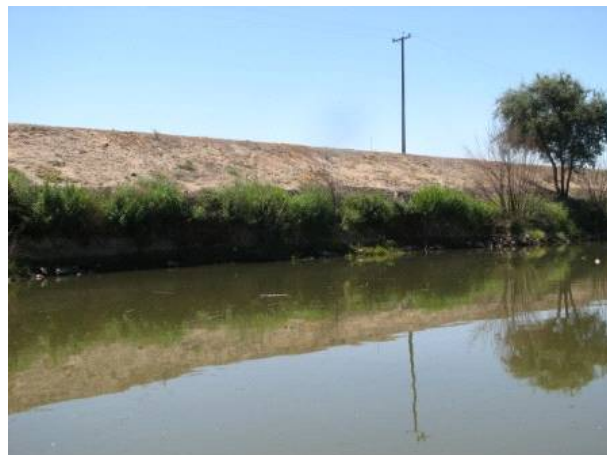
Levee Mile Report Line	6
Start Levee Mile	0.23
End Levee Mile	0.32
Location	Water Side
Category	Supplemental
Item	DWR Erosion Survey
Front view of the site with dense vegetation.	
SJ2011_RD2062U03RM30.19_3.jpg

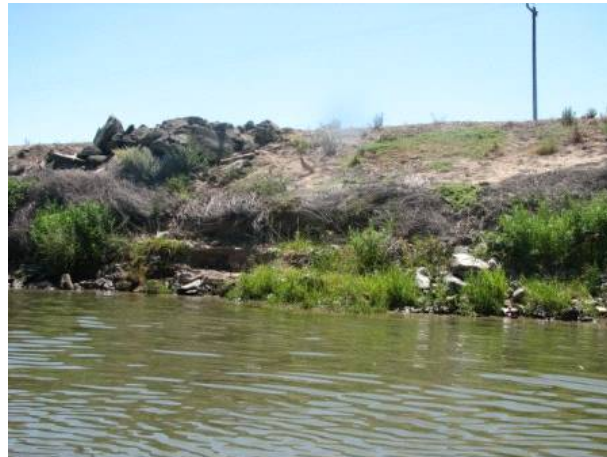
SJR2011_RD2062U03RM30.27_1.jpg

Levee Mile Report Line	7
Start Levee Mile	0.35
End Levee Mile	0.35
Location	Water Side
Category	Supplemental
Item	DWR Erosion Survey

Direct view of the erosion. Note the broken concrete near the site.

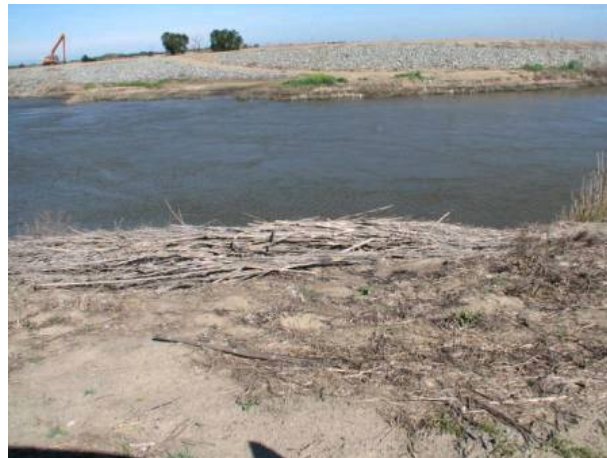
jeto_f_20110923_198.jpg

Levee Mile Report Line	8
Start Levee Mile	0.46
End Levee Mile	0.46
Location	Water Side
Category	Earthen Levee
Item	Encroachments

05/11/2011 Bambo prunings have not been removed. This item was noted in the Fall 2010 inspection.

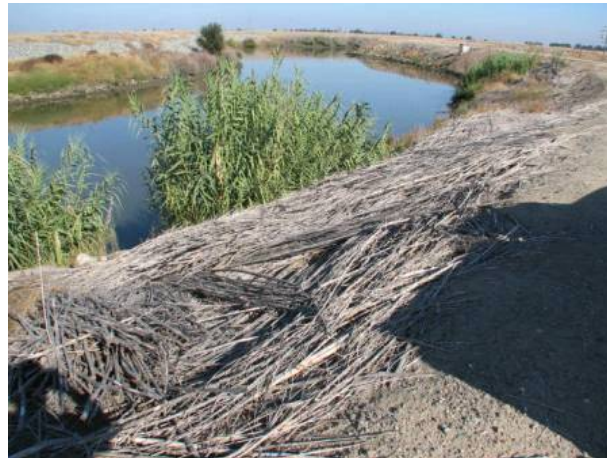
Levee Mile Report Line	8
Start Levee Mile	0.46
End Levee Mile	0.46
Location	Water Side
Category	Earthen Levee
Item	Encroachments
10/20/2011 Bamboo (Erundo) cuttings still present issue is not being addressed.	
jeto_f_20111024_485.jpg

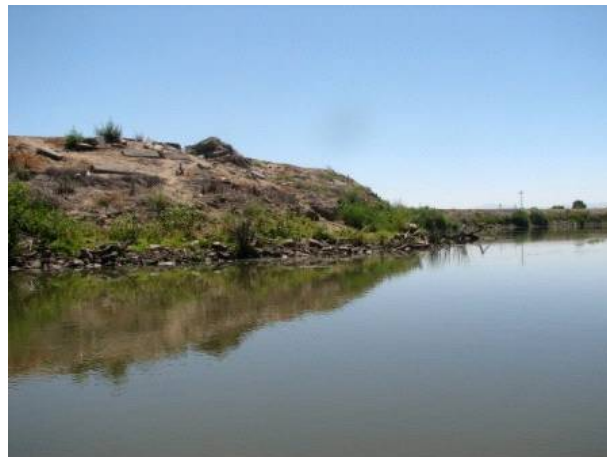
Levee Mile Report Line	9
Start Levee Mile	0.56
End Levee Mile	0.57
Location	Water Side
Category	Supplemental
Item	DWR Erosion Survey
Upstream view of the site.	
SJR2011_RD2062U03RM30.43_1.jpg

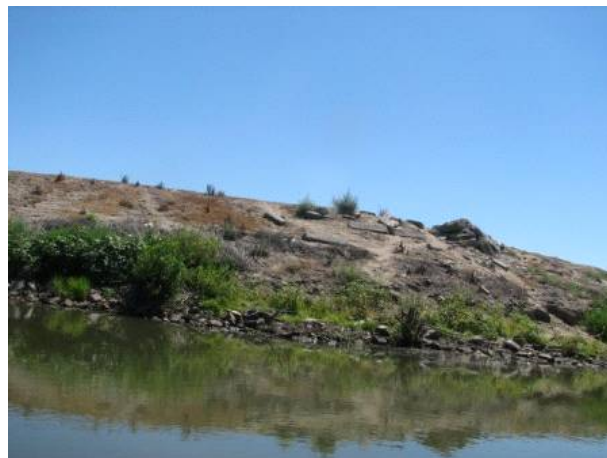
Levee Mile Report Line	9
Start Levee Mile	0.56
End Levee Mile	0.57
Location	Water Side
Category	Supplemental
Item	DWR Erosion Survey
Front view of the site. Previously placed rip rap slipped, exposing the underlying soils and creating a pocket.	
SJR2011_RD2062U03RM30.43_2.jpg

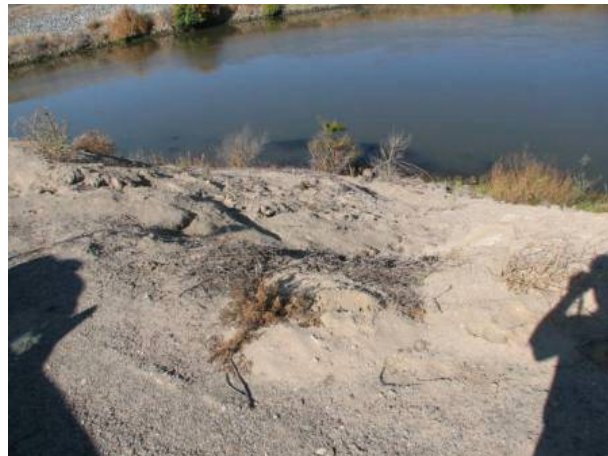
Levee Mile Report Line	13
Start Levee Mile	0.82
End Levee Mile	0.82
Location	Water Side
Category	Earthen Levee
Item	Erosion / Bank Caving

10/20/2011 Photo shows no change in condition since last reported in the Spring 2011 inspection.

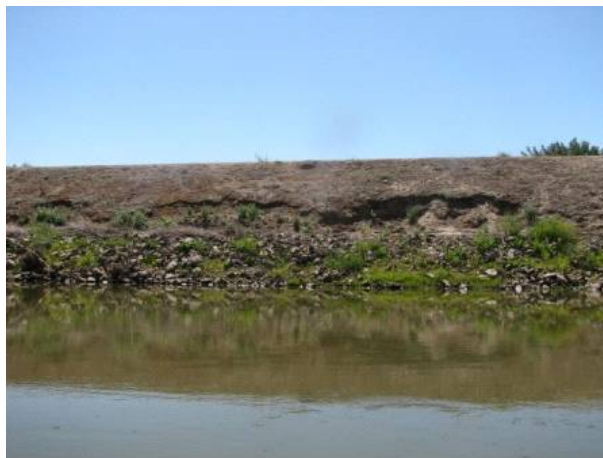
Levee Mile Report Line	14
Start Levee Mile	1.20
End Levee Mile	1.21
Location	Water Side
Category	Supplemental
Item	DWR Erosion Survey

Front view of the site. Note the lateral crack along the middle slope

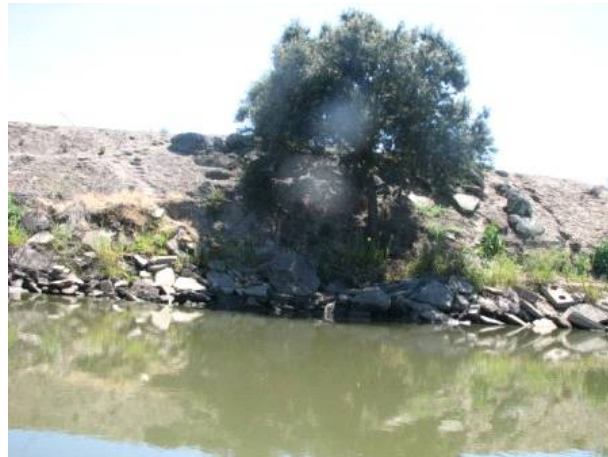
Levee Mile Report Line	18
Start Levee Mile	1.42
End Levee Mile	1.43
Location	Water Side
Category	Supplemental
Item	DWR Erosion Survey

Front view of the site. Note existing broken concrete on the upper slope as well as on the lower slope and at the toe.
